## **Introduction**

This report is written as representing Stoney Stanton Parish Council regarding the flooding that occurred between 29<sup>th</sup> December 2023 and 2<sup>nd</sup> January 2024.

## **Stoney Stanton Flooding 2<sup>nd</sup> January 2024**

### **Stoney Stanton Flooding 30<sup>th</sup> / 31<sup>st</sup> December 2023**

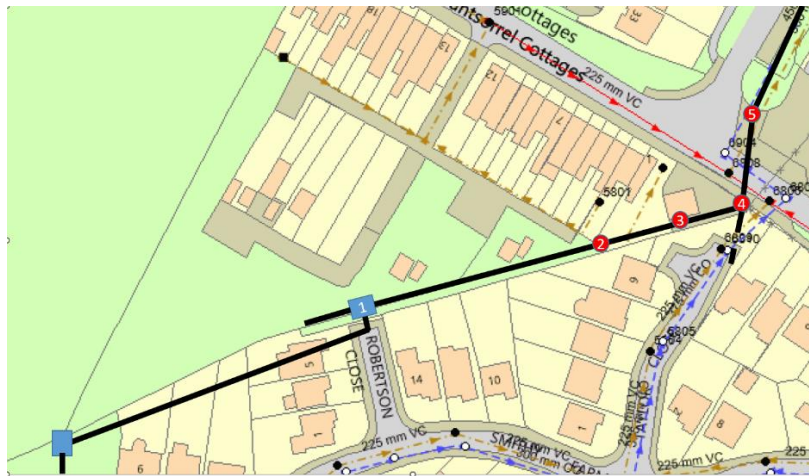
Water levels rose and breached the brook to the rear of Station Road flooding the road and rear gardens of the properties as seen in Pic. 14, the water was also spilling from the headwall which is indicated as point 1 in Pic. 1. We believe that this is exasperated by the inability of water to flow from the rear of the properties and away. Still in place is the 300mm pipe that connects to the rear of all of the properties, this comes to a manhole in the pavement adjacent to 12 Station Road. This pipe then continues across the road in 300mm diameter. Originally this pipe fed directly into the field without restriction prior to the building of Godfrey Close. During the building the pipe was capped in a chamber with a manhole and is now directed at 90 degrees through a 4" plastic U/G pipe, it is the belief that this pipe terminates approximately 20m to along the grass bank with no outflow. This has been raised in 2019 as a concern as there is nothing apparent in the planning documentation or water plans for the building of the Godfrey Close development.

Pic. 1 - Watercourse overview to the rear of Station Road.

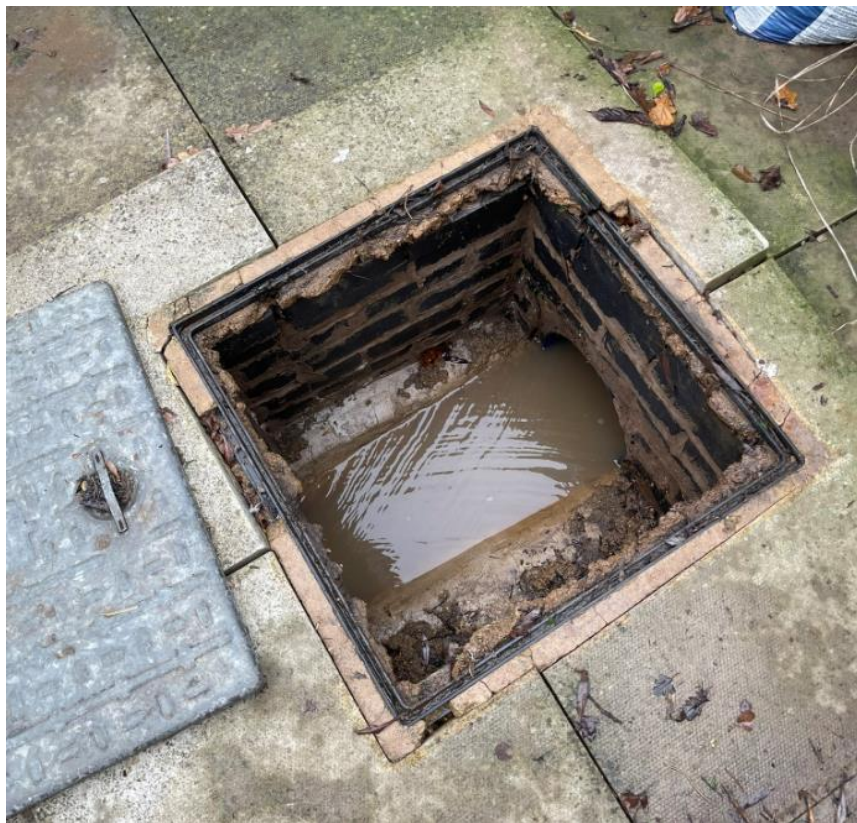
Pic. 2 – Flow through manhole 3 at 8:47 2<sup>nd</sup> January 2024.

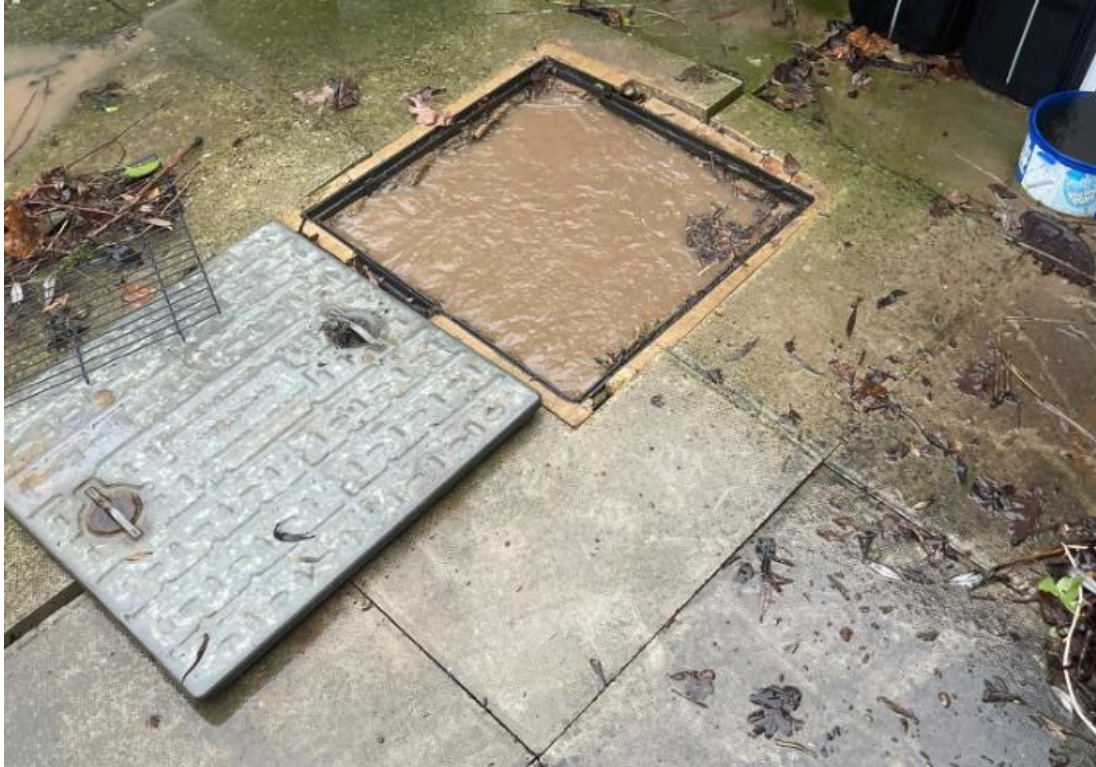
The rainfall commenced around 10am with around 0.8mm/hr and increasing to around 4mm/hr by 13:00 when the water level began to rise to the rear of 1 Station Road and the manholes and pipework became backed up and surface flow commenced (Pic. 3 manhole 3 & Pic.4 manhole 5). At the same time the overflow from the manhole adjacent to SJ Cars on the chevrons was flowing with significant volumes of water, and the drains on the entrance to Foxbank Industrial Site became overwhelmed and stopped accepting water, this resulted in the water level on the entry road becoming deeper. At this point the garage adjacent to 1 Station Road as well as that to the rear of 6 Station Road to a level of approximately 150mm occurred and remained flooded until the water receded around 19:30.

Pic. 3 Flow through manhole 3 at 12:50 2<sup>nd</sup> January 2024

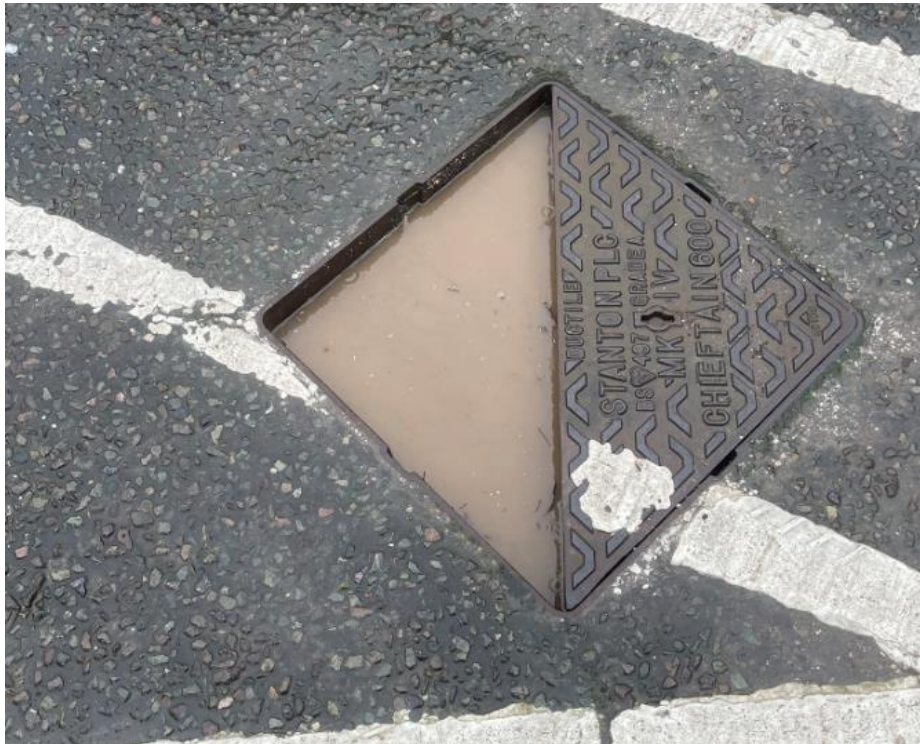
Pic.4 Manhole 5 at 13:02 2<sup>nd</sup> January 2024

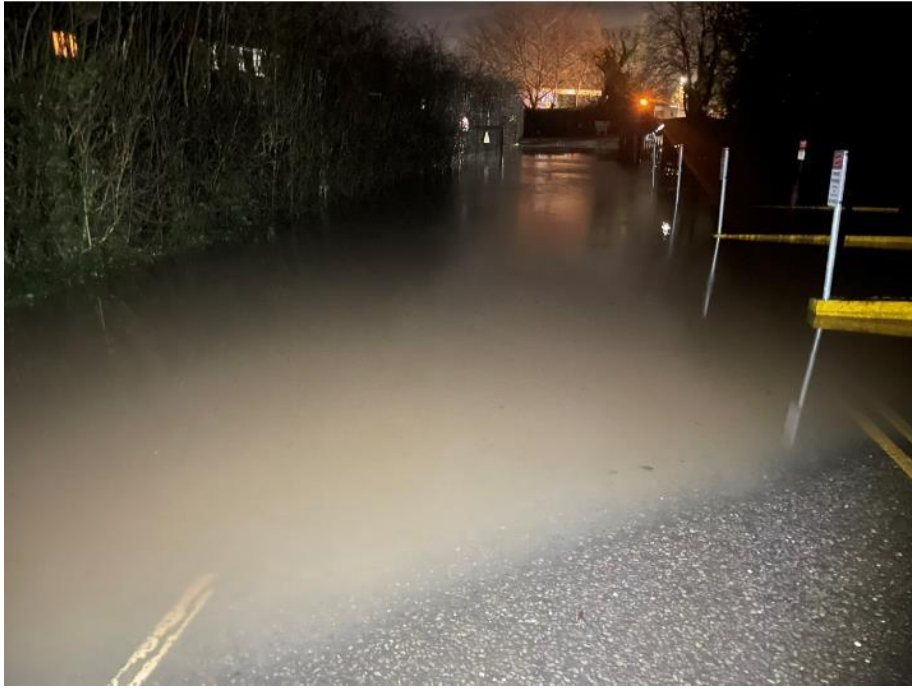
Pic.5 High water level at the entrance to Foxbank Industrial Estate 19:26 2<sup>nd</sup> January 2024

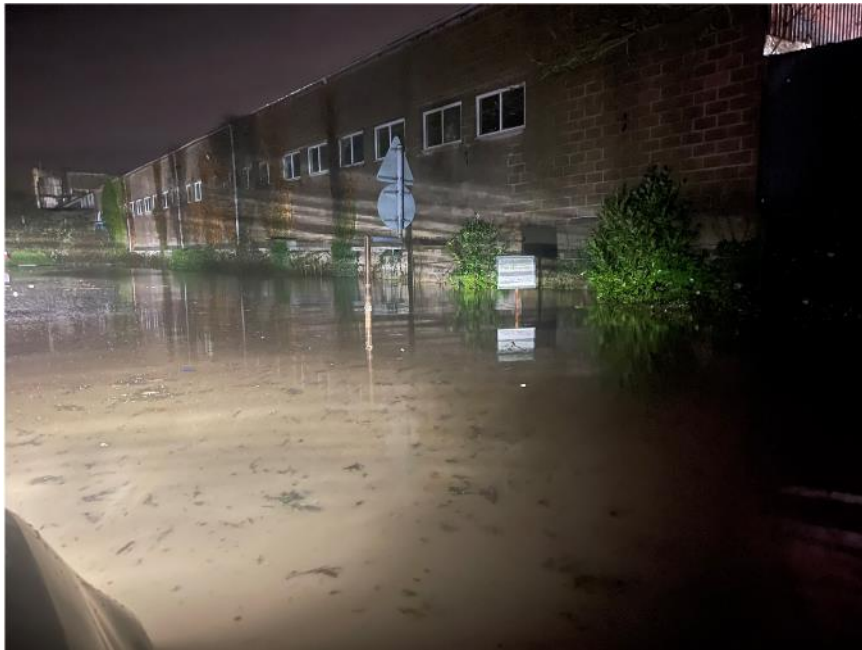
Pic. 6 High Level at the restrictor plate 19:29 2<sup>nd</sup> January 2024

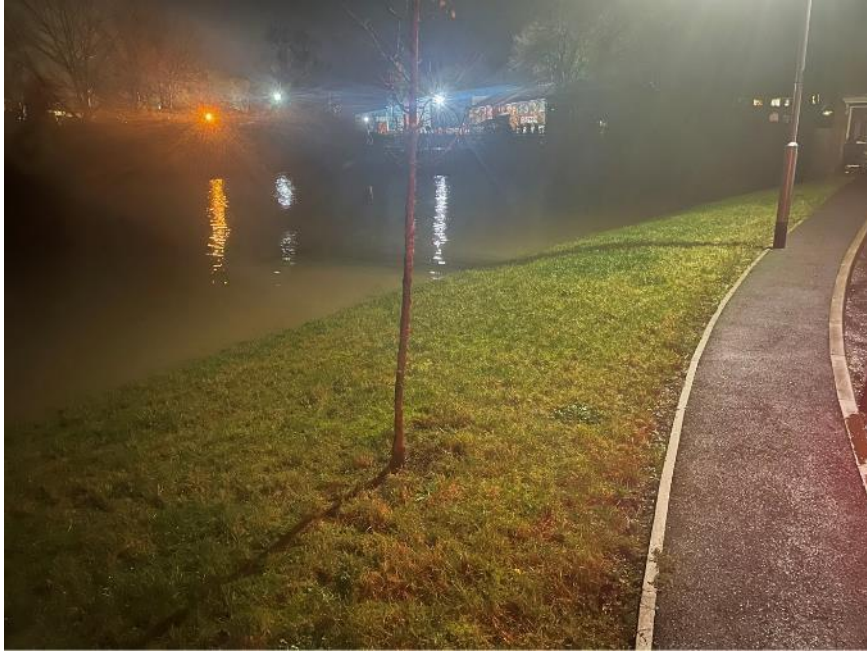
Pic. 7 High Level at Godfrey Close Floodplain 19:24 2<sup>nd</sup> January 2024

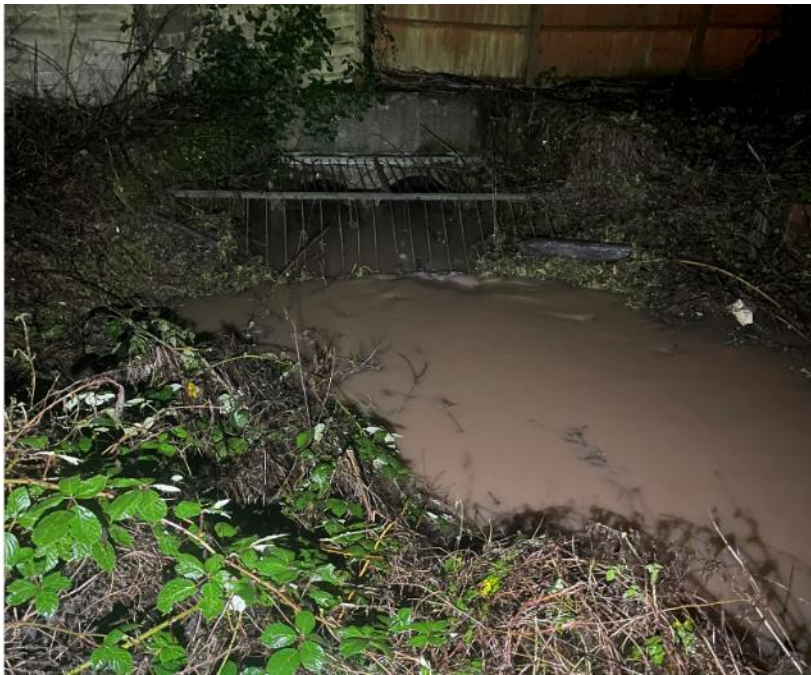
The rain ceased falling around 19:00 and within 45 minutes of this happening the water levels had begun to recede and by 20:30 the pumping was able to stop and the water level no longer posed a risk to the residential properties. At around 19:00 a suitable vehicle was found that could drive through the flood water to inspect the restrictor plate (Pic. 6 & 7) and understand what was happening. This inspection showed that there was very little overflow from the restrictor indicating that it was indeed blocked or on minimal flow. An inspection of the outfall from the culvert under the Stressline complex appeared to confirm this with limited flow aligned with levels of water where flow was just through the restrictor, this was also observed at the twin culverts ahead of Meadow Close (Pic. 8).

Pic. 8 Water Flow through Twin Culverts 19:47 2<sup>nd</sup> January 2024– Point 9106 Severn Trent Water Locations

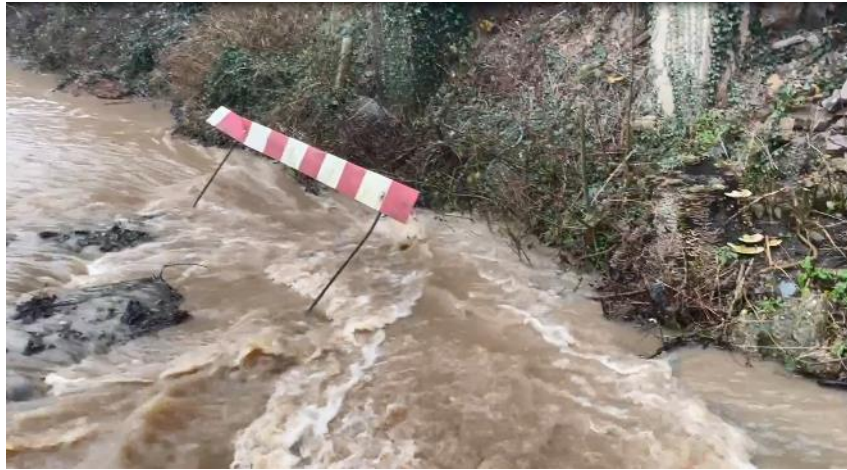
The rain fell steadily throughout the day at a peak level of around 6.8mm/hr. By 14:02 the water had risen the level where it was flowing over the top of the restrictor plate and through the grate (Pic 9 & 10). When this starts to happen it puts increasing pressure on the systems that protect the Meadow Close development and a visit to the residents there showed the water level increasing, although the systems were coping and running around 85% peak flow through the twin bore pipes (Severn Trent Location 9106). The same was confirmed by residents and Blaby District Council by viewing the outfall from these pipes in the Manor Brook (Severn Trent Location 0106). The systems continued to be monitored throughout the day to ensure they were not becoming overwhelmed.

Pic. 9 Water Flowing into the restrictor plate overflow 14:02 2<sup>nd</sup> January 2024

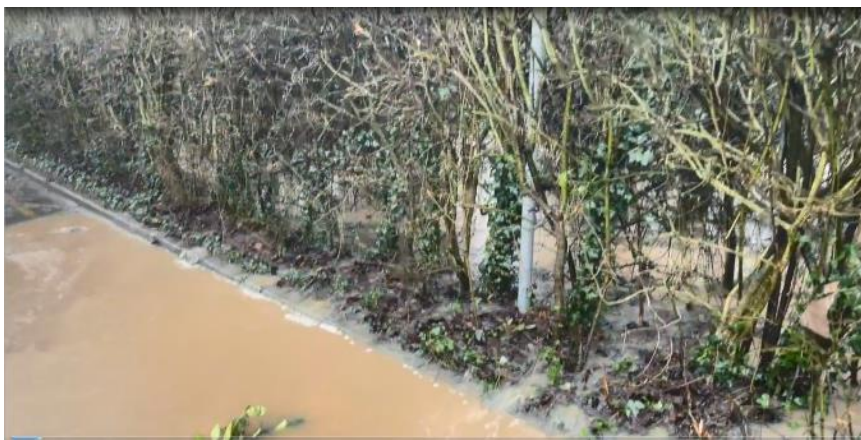
Pic.10 Water Flowing from the Godfrey Close Floodplain towards the restrictor 14:04 2<sup>nd</sup> January 2024

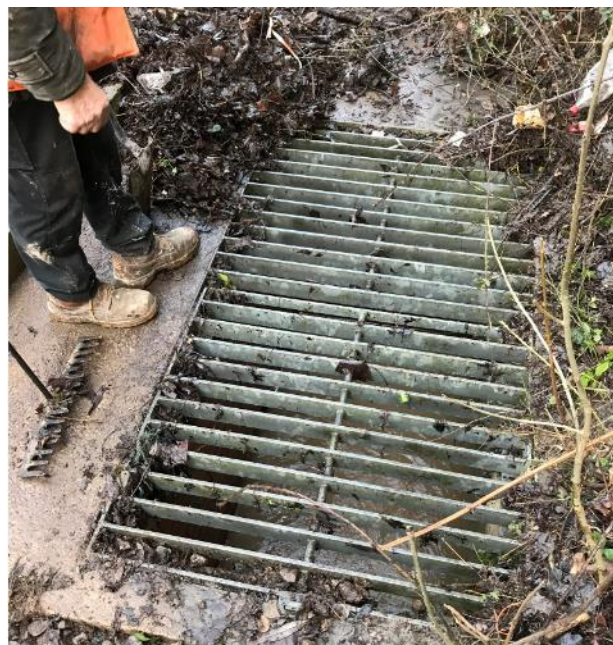
by the restrictor plate which was running at full flow. The grate to the top of the restrictor plate was heavily blocked with hardcore and mud, this was cleared to ensure as the water rose it could work as it was intended.

Pic. 11 Restrictor Overflow Grate post cleaning and water level receding.

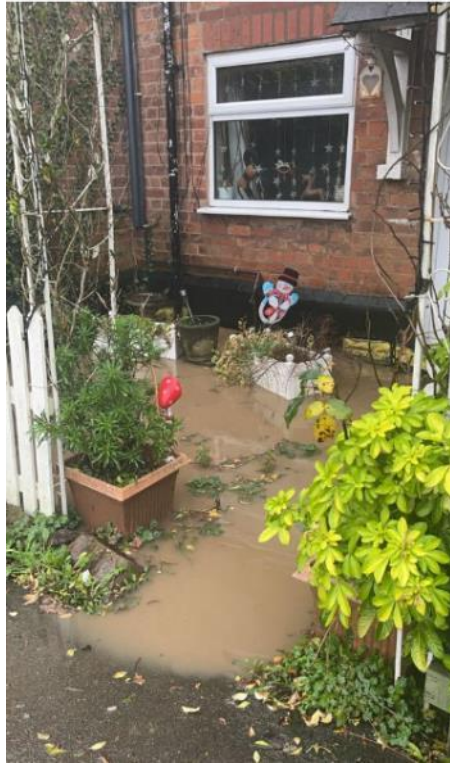
kitchen systems. The water then flowed around the front face of the property and began to accumulate around the front entrance to 2 Station Road which is a step down from number 1 and also to the road, meaning that water needed to be bucketed out of the area as well as using 2 different pumps. This meant that the flood water did not enter the property, although it was above the level of the air bricks under the front window.

Pic. 12 Flooding to front of 2 Station Road 13:50 2<sup>nd</sup> January 2024

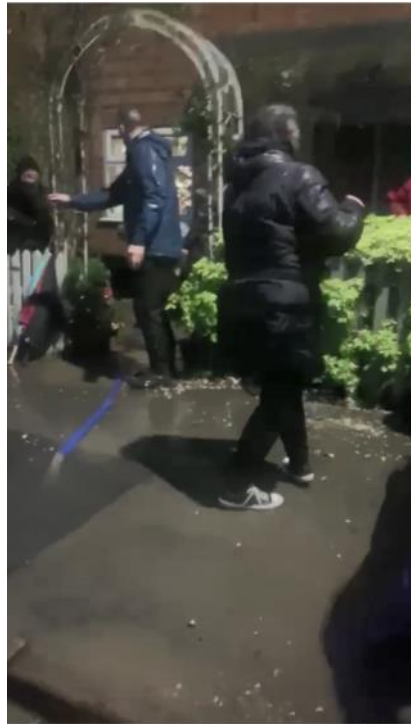
Pic. 13 Residents pumping and bucketing water from the front garden of 2 Station Road 16:20 2<sup>nd</sup> January 2024

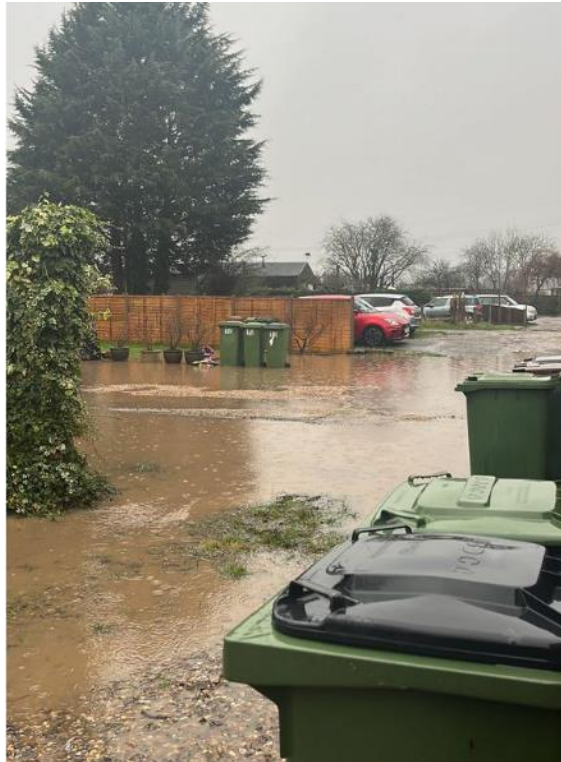
Pic. 14 Water accumulating to the rear of Station Road homes overspilling the bank of the brook and pooling in gardens 14:21 2<sup>nd</sup> January 2024

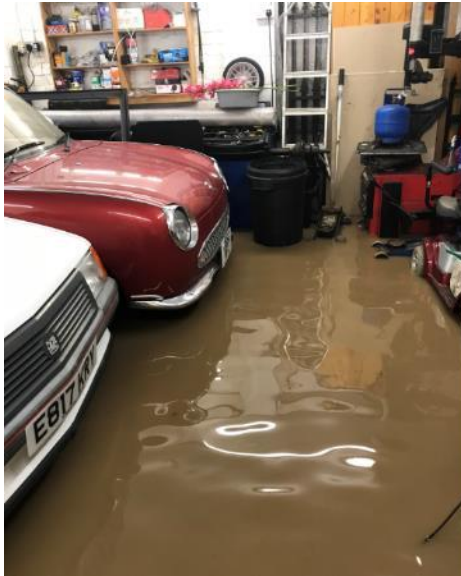
Pic. 16 Garage adjacent to 1 Station Road, water level peaked at 175mm 16:48 2<sup>nd</sup> January 2024.

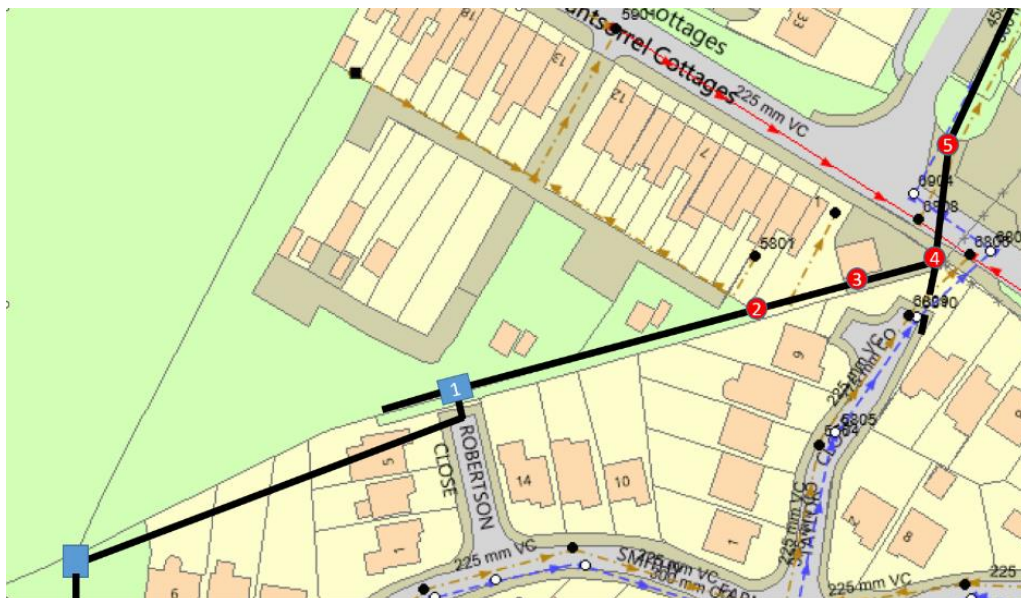
The head wall adjacent to Roberston Close (Point 1 on Pic. 1) was overflowing and water was flowing down the central driveway to the road. The manholes were lifted to the rear of the garage adjacent to 1 Station Road (Points 2, 3 & 4 on pic. 1) where they were full with no indication of movement of water. The same situation was present in the manhole located on the chevrons adjacent to SJ car sales Point 5 on pic.1) . This is the manhole that houses the large bore interceptor and has the outfalls through a 300mm low level pipe that runs via 2 further manholes to the restrictor plate in Stressline, and also has a high level 450mm overflow pipe that should send water down the Stressline drive and into what was the field.

Pic. 1 – Watercourse overview to the rear of Station Road.

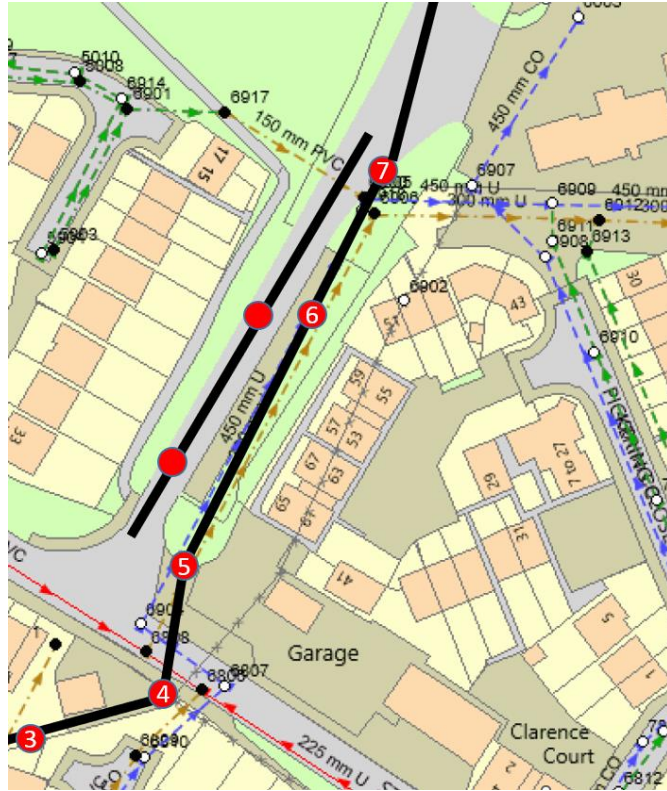
It immediately became clear that there was no water flowing from the manhole adjacent to SJ Car Sales through the bottom main pipe, this was verified by opening the manhole to the rear of parking bay 7 on the Stressline drive (Point 6 on Pic. 2 and Pic 6) and seeing no flow coming from the outfall of the pipe, the pipe from the manhole to take water away was completely empty. In the photos you will note there are significant sections of broken up vitrified clay pipe in and around the manhole. No flow through this pipe led to the system backing up. At this point the water should have been able to flow from the overflow 450mm pipe (Pic. 8), however at this point the pipe and its outfall are significantly below the height of surrounding ground meaning the water is unable to flow from here

Pic.2 – Manholes and pipework to the Stressline Drive

In order to mitigate the issues with this watercourse it is the opinion of the residents that the 300mm main feed pipe must be surveyed and replaced without delay to allow the ordinary flow of water from the systems, the overflow must be put back to as designed to ensure in the event of extreme water flow the water is able to run off and be managed by the restrictor plate and the flood plain. As always we are happy to engage and would like to understand how firm actions can quickly be put in place.

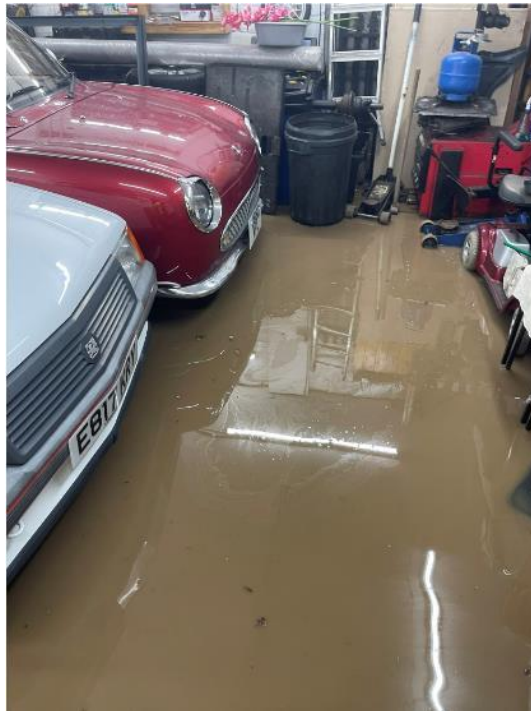
The water levels rose and flooded the garage adjacent to 1 Station Road to around 110mm in depth. The adjacent properties at the time of the call were approximately 50mm below the rear thresholds of properties 1, 2 & 3, in the case of 2 Station Road the air bricks were underwater. The water was rising from the brook to the rear of the cottage in what appeared to be backing up of the system on first sight as there was no indicated flow through the system.

Pic. 3 Flooding of garage adjacent to 1 Station Road

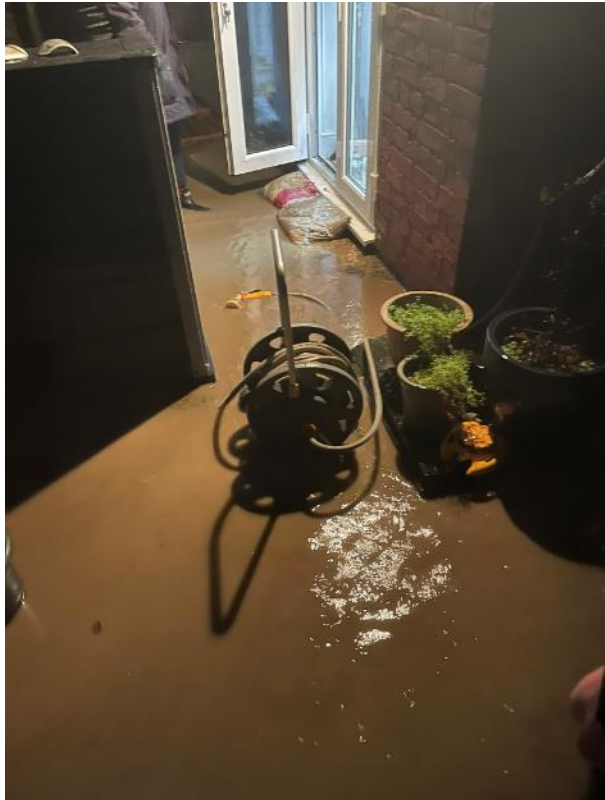
Pic. 4 Rear of 1 Station Road

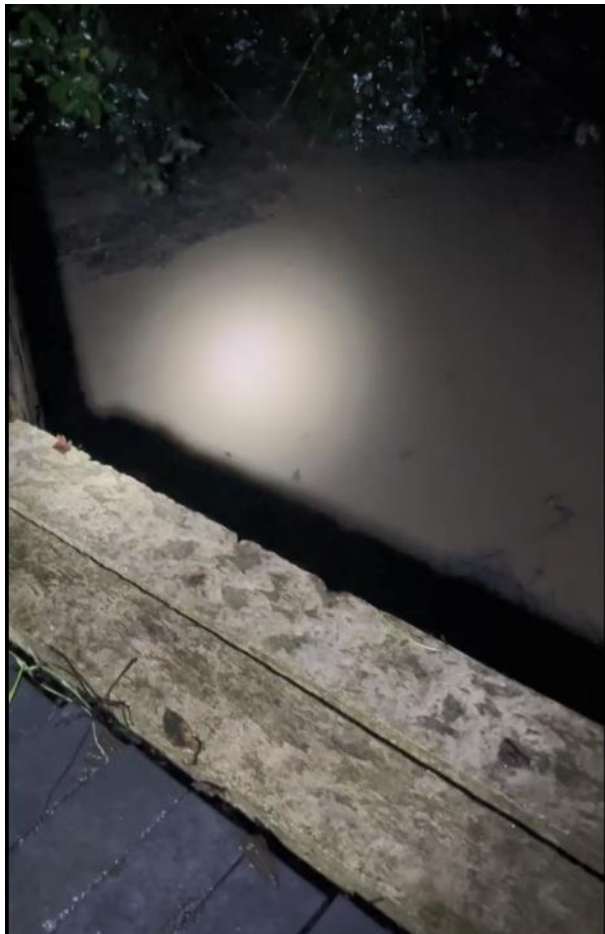
Pic. 5 Location 2 water level

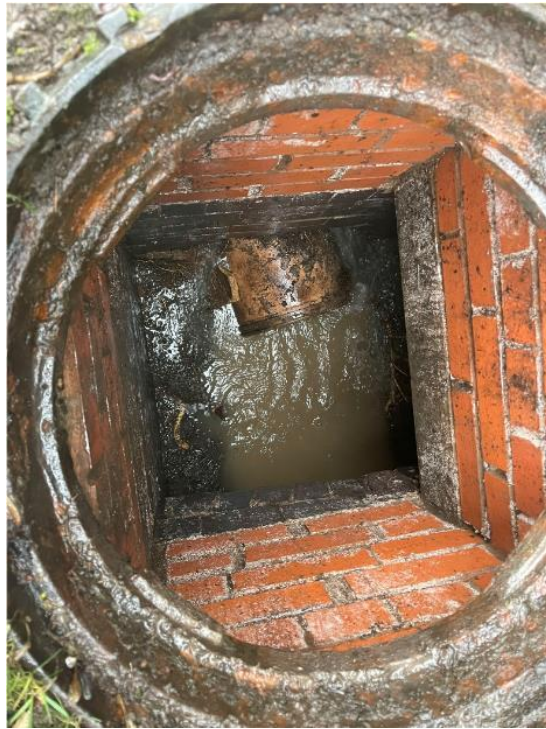
The issues with both of these pipes was originally raised in March 2020 with Leicestershire County Council and the flooding cohort of agencies that were formed. It was further identified during surveys by LCC that the 300mm pipe had collapsed and this was verified when video footage was obtained by Pete 'Boyle'? on behalf of LCC. The overflow is indicated on the plans of the development as a ditch that originally ran to the bottom of the drive and onto the land which is now occupied by Bellway Homes Godfrey Close development.

Pic. 6 Manhole 6 with no water flowing through (Note the multiple pieces of broken pipework)

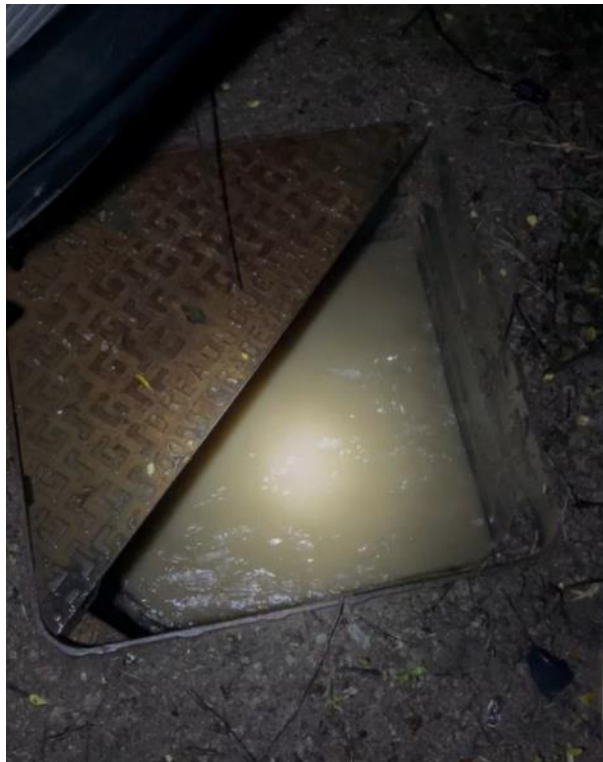
Pic. 7 Manhole 4 full with no indicated water flow

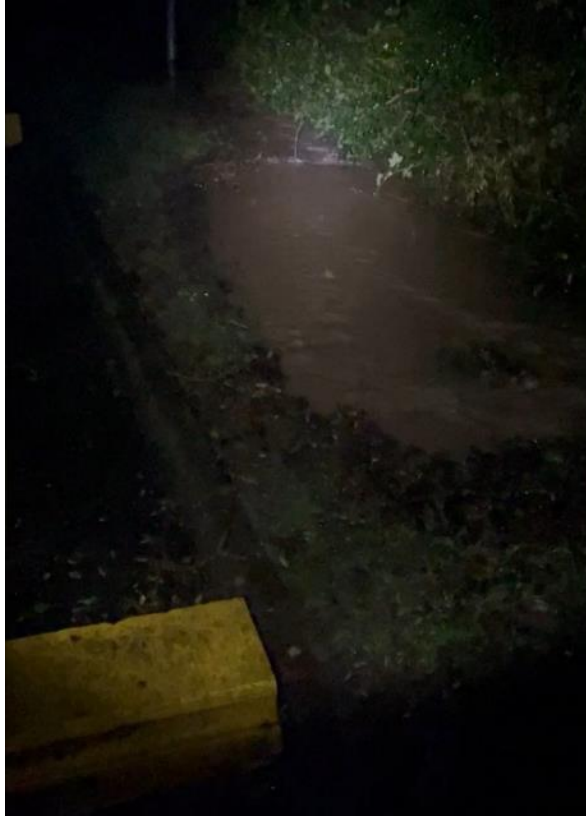
Pic. 8 Overflow from manhole 5 with no where for the water to go.

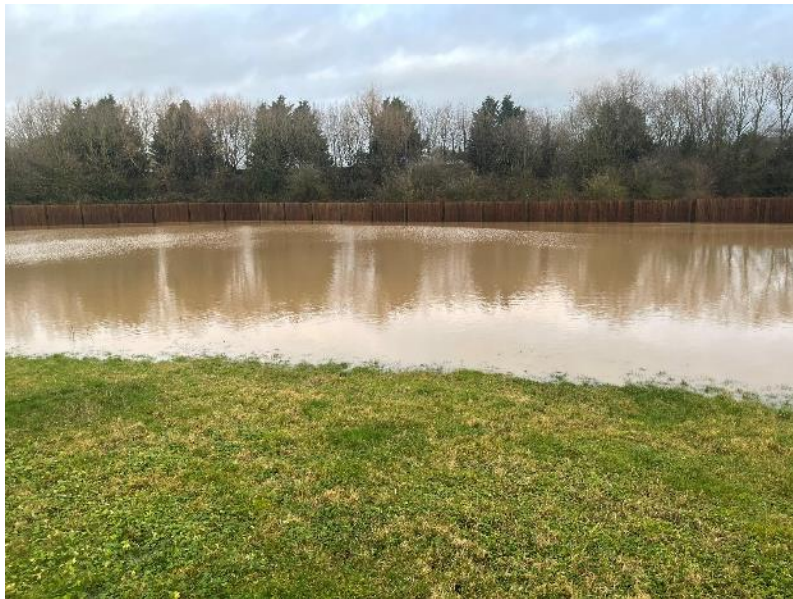
Pic. 9 Flooding to rear of Godfrey Close (Pic taken 31<sup>st</sup> December @ 9am
